ONE WORLD TRADE CENTER FIRE

New York, N.Y.
February 13, 1975

WTCI-486-P

HIGH-RISE FIRE SAFETY

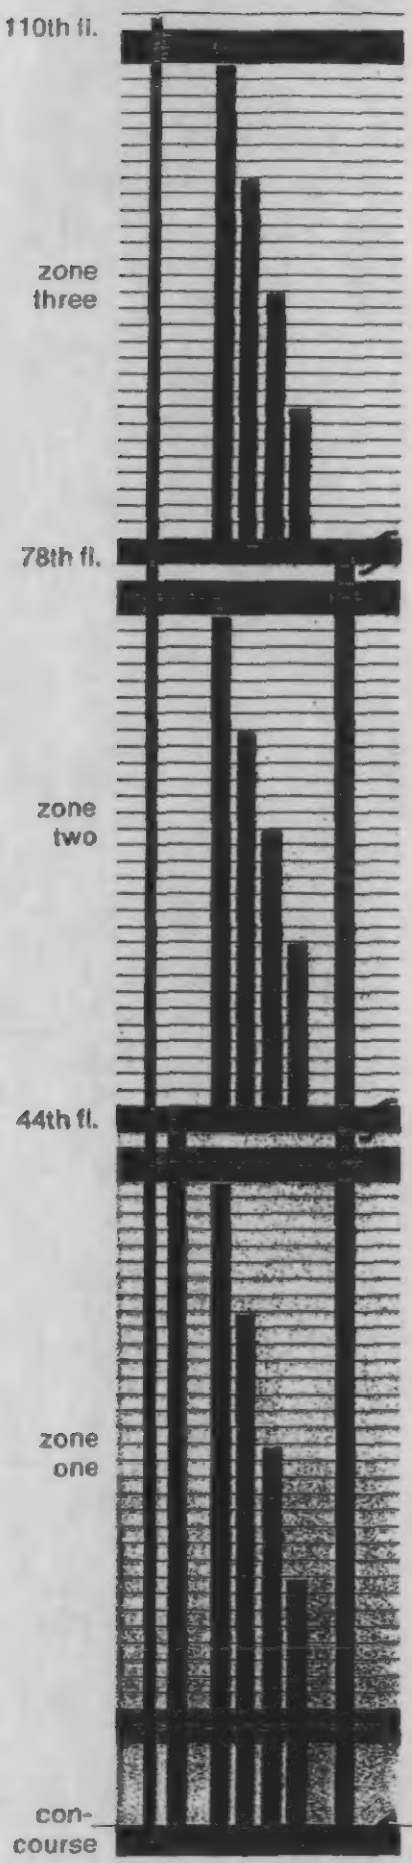
Schematic view of Tower building elevators shows how express and local runs are separated.

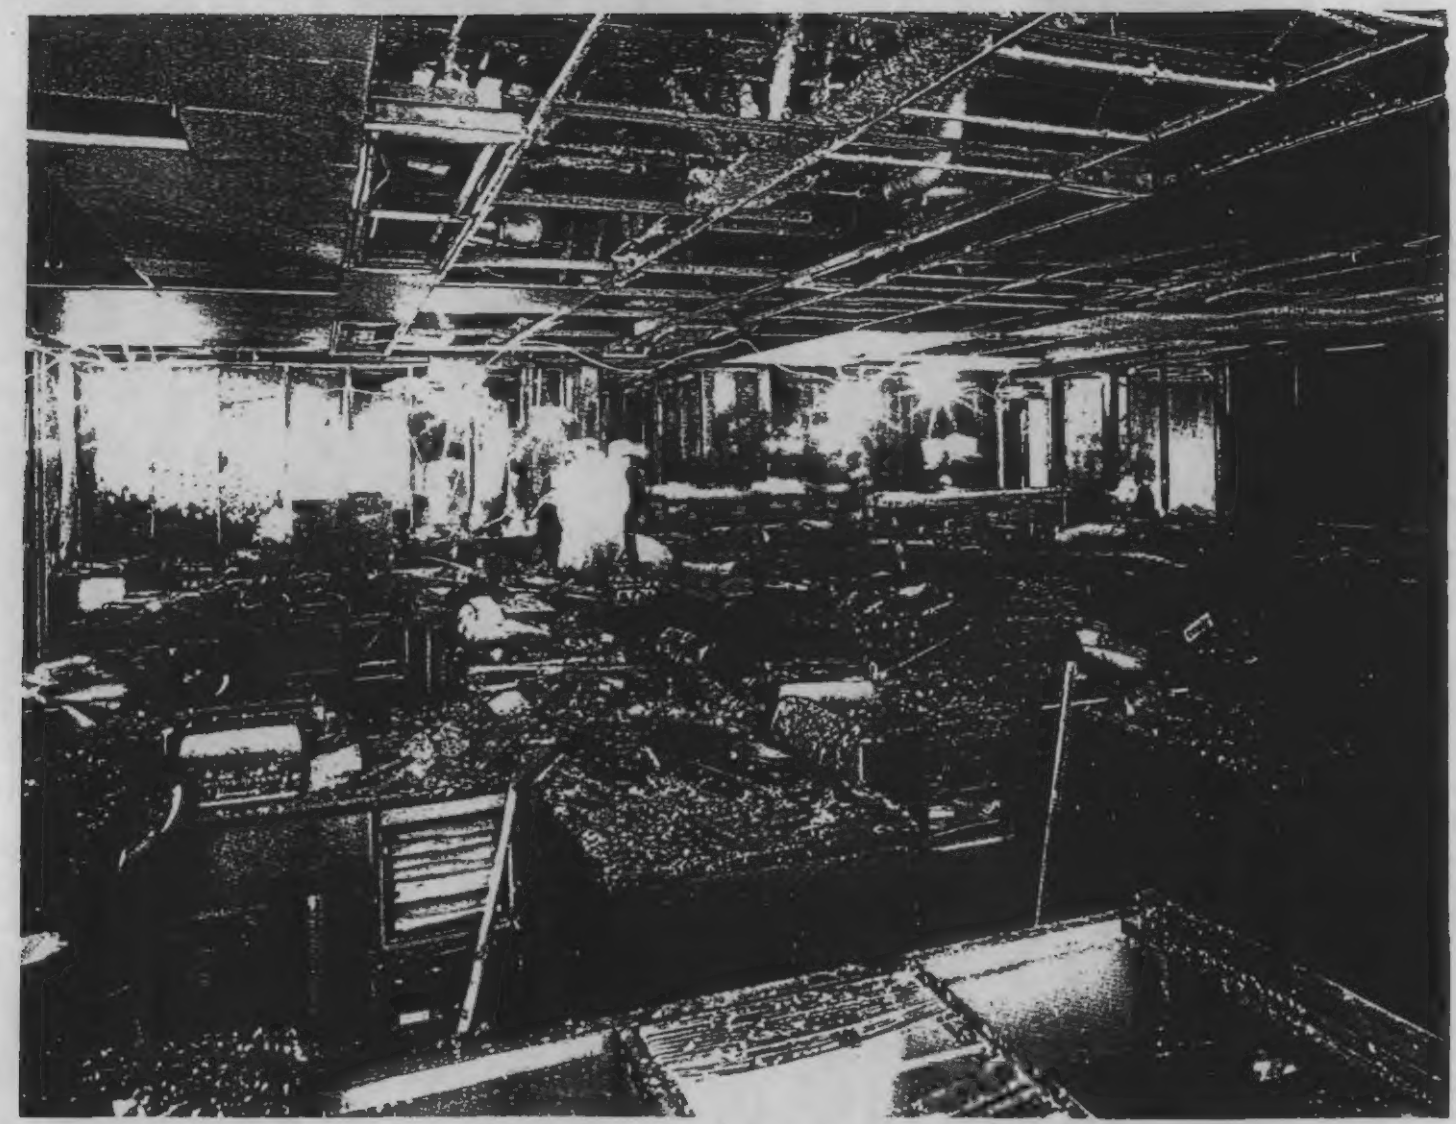
R. J. Saunders office on 11th floor file room is at left and office of fire origin is behind partition at right of picture.

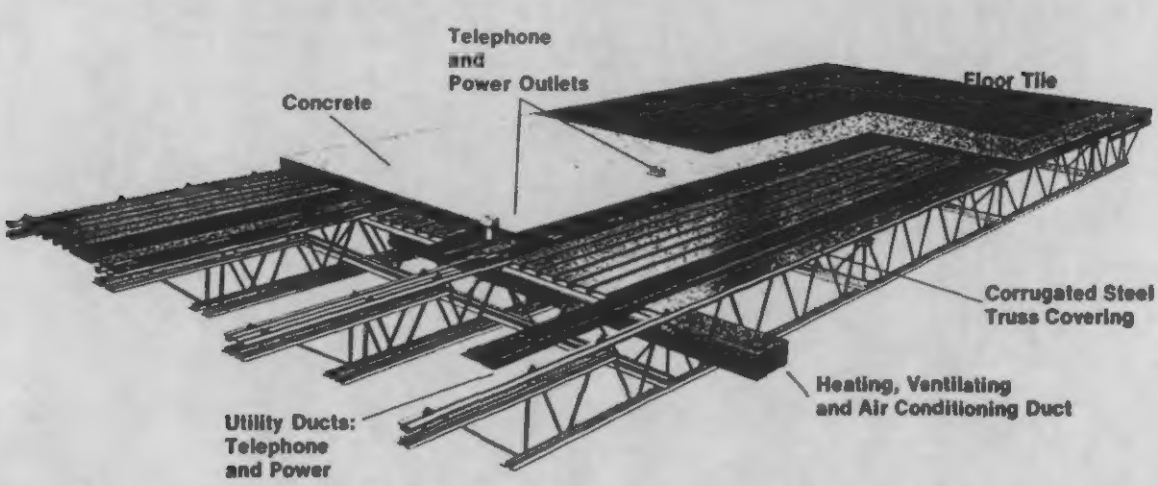
Floor truss in close-up detail. Following placement of truss, *the corrugated top was covered by concrete floor slab* and tile surface. Underneath, a network of utility and air conditioning ducts traverse the 32-inch deep-cavity.

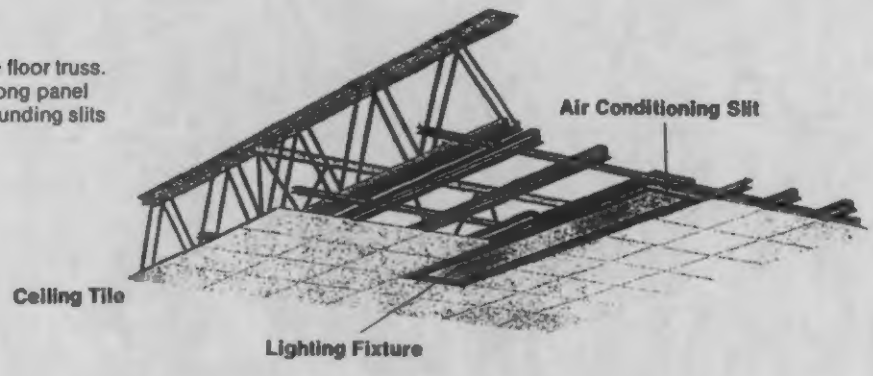
Looking upward at the same floor truss. Ceiling tile is in place. The long panel provides lighting, with surrounding slits for air conditioning.

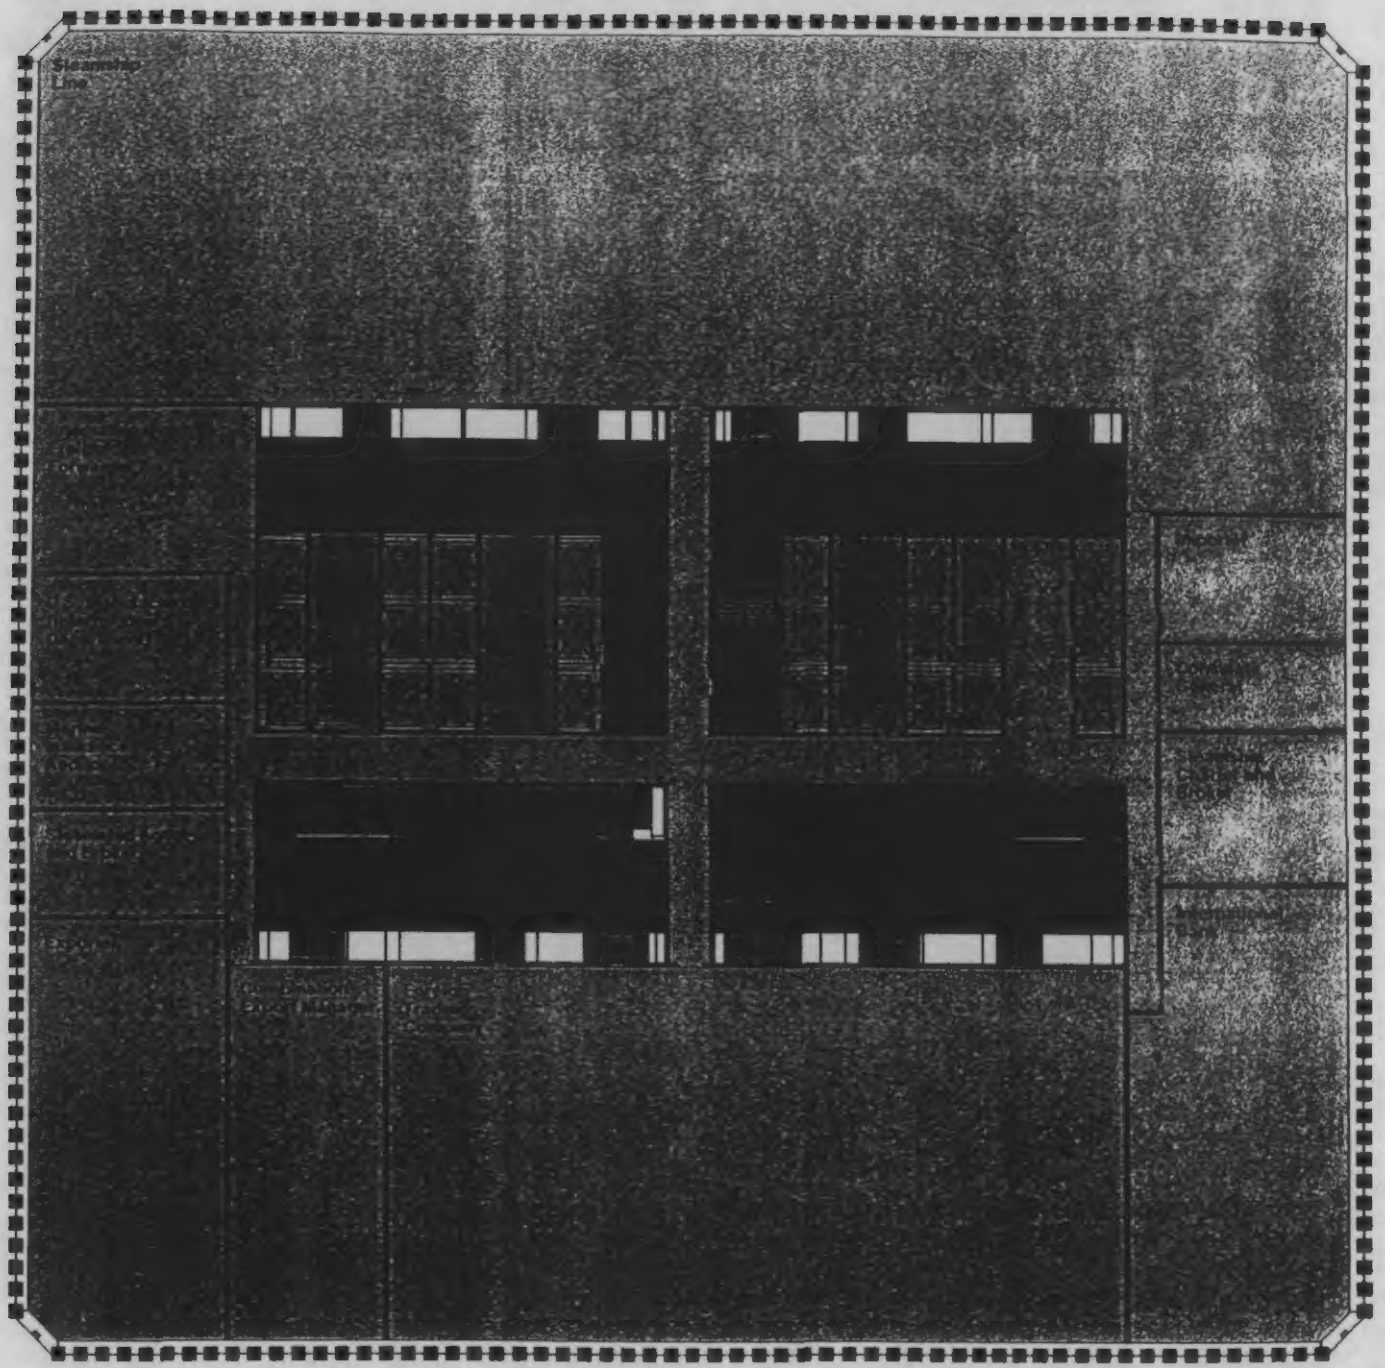
Plan of a typical tower building floor indicating areas occupied by
